# Xserve G5 CD Drive Replacement

Today I will replace this little CD drive on my Xserve G5 guys ! And I will show you how to do !

Written By: alphaLONE

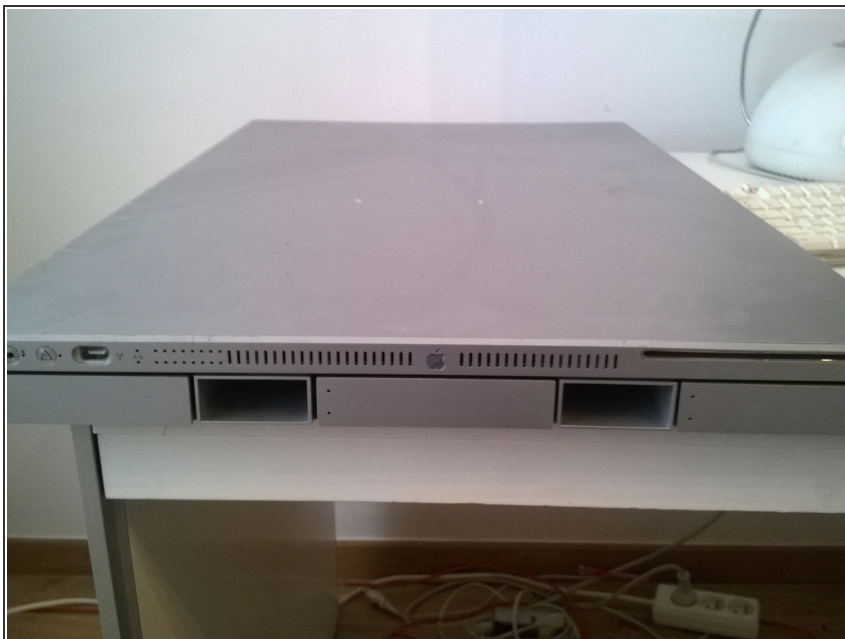
## Step 1 — CD/DVD drive

- Here's my dead Xserve G5. I need a new power supply for it. So he will serve for the demo.

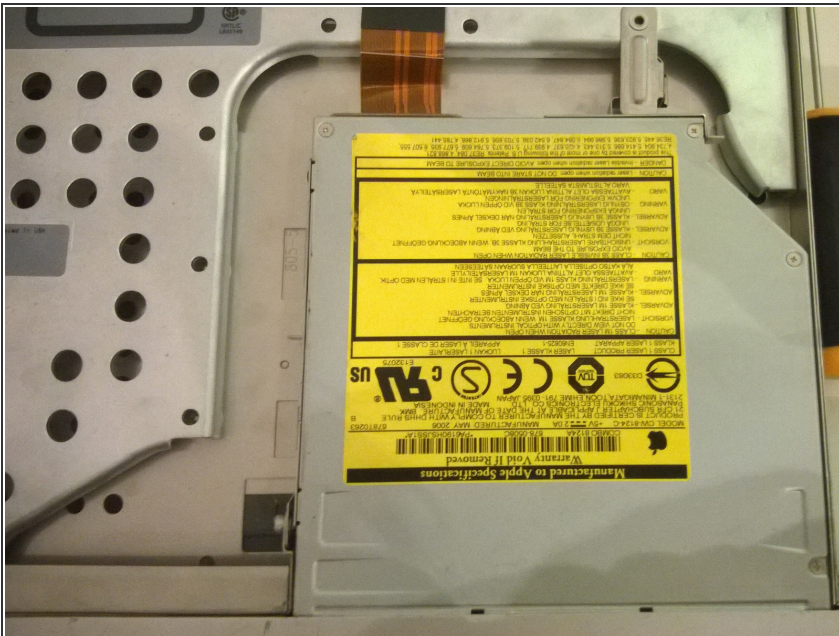
## Step 4

- Hello little CD drive ! It's retirement time !
